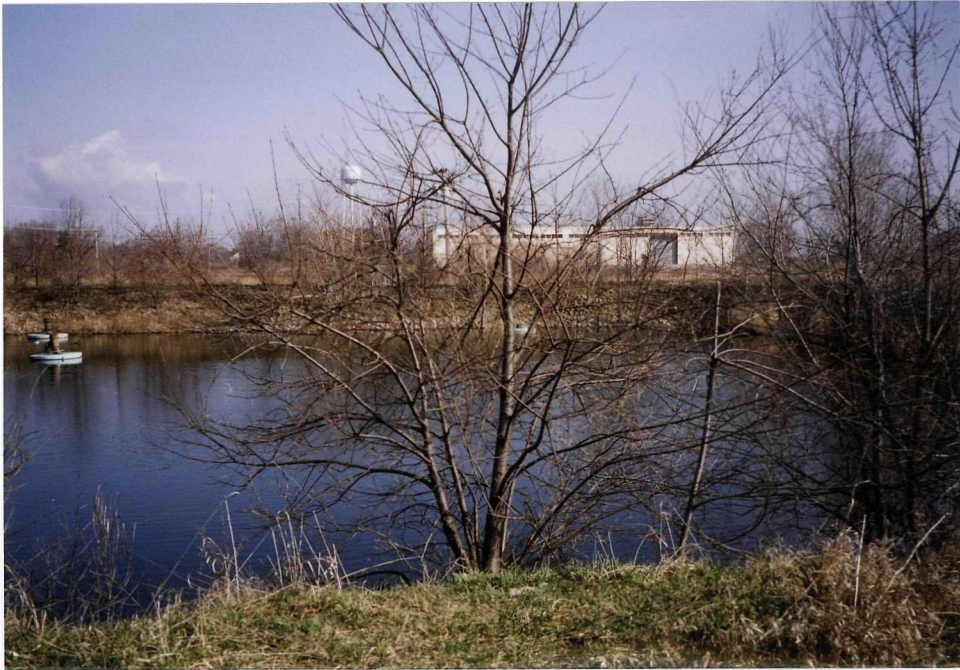
Site: Diamond International Corporation
Proj#: 71380.114 - ILD 980 683 197
Roll: 2 Photo #: 1
Date: 03/30/95 Time: 0910
Photographer: John Noyes
Description: Large lagoon with aerators, water, and rocky shore.
Onsite storage building in background. View is to
the north.

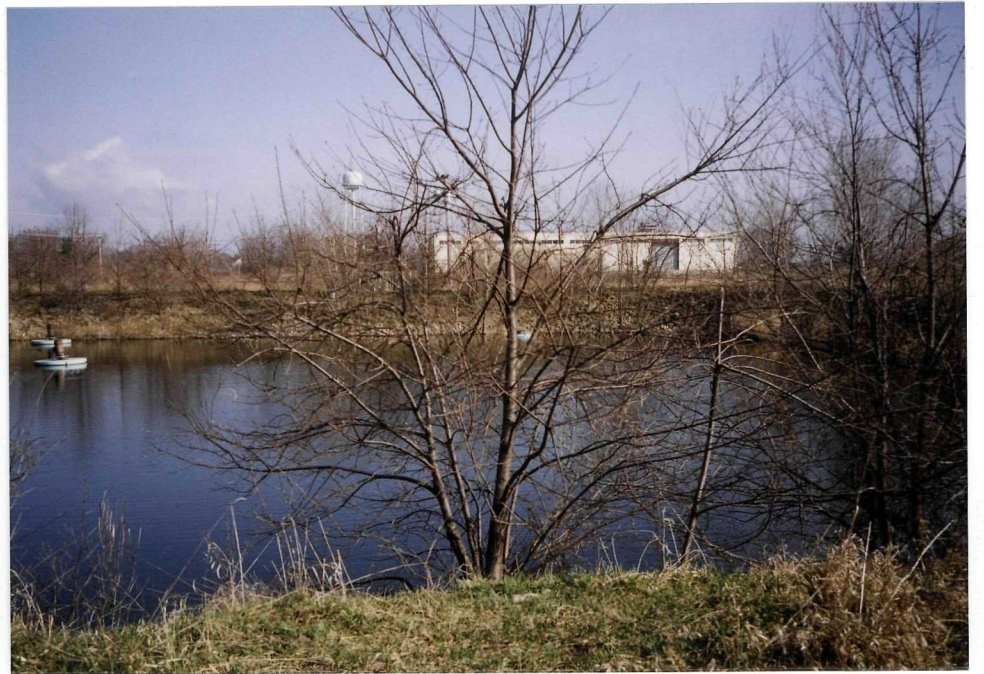
Site: Diamond International Corporation
Proj#: 71380.114 - ILD 980 683 197
Roll: 2 Photo #: 2
Date: 03/30/95 Time: 0910
Photographer: John Noyes
Description: Large lagoon with aerators, water, and rocky shore.
Onsite storage building in background. View is to
the north.

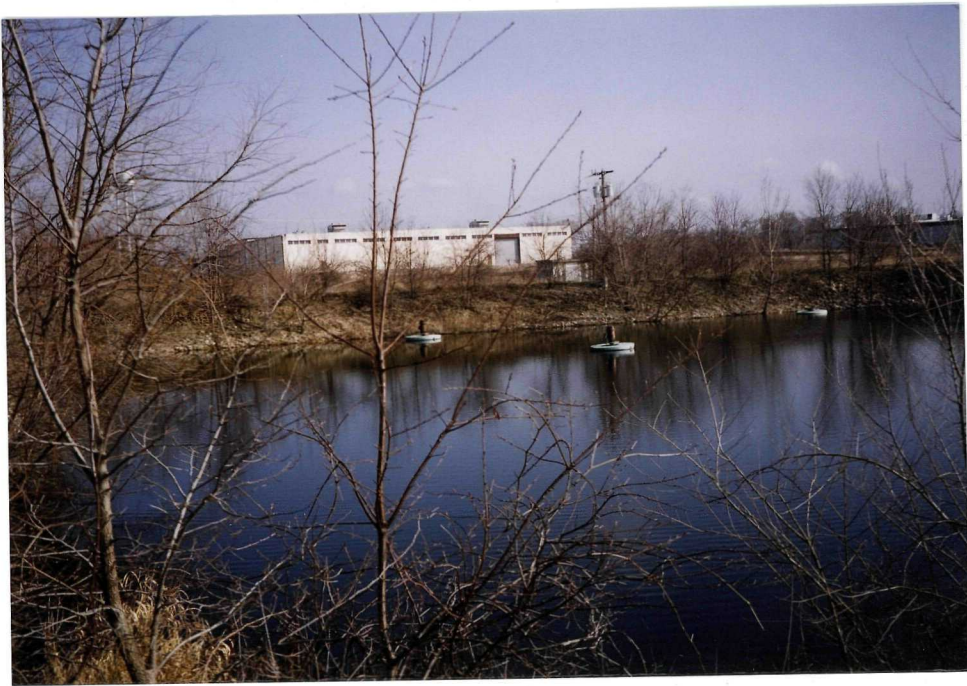
Site: Diamond International Corporation
Proj#: 71380.114 - ILD 980 683 197
Roll: 2 Photo #: 3
Date: 03/30/95 Time: 0913
Photographer: John Noyes
Description: Large lagoon with aerators, water, and rocky shore.
Onsite storage building in background. View is to
the northeast.

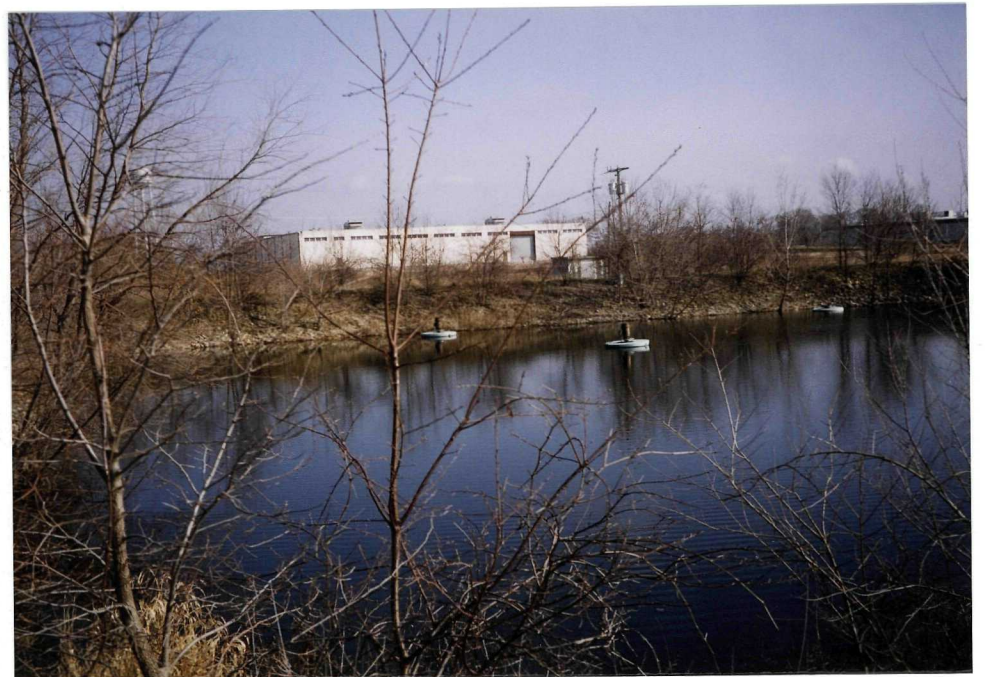
Site: Diamond International Corporation
Proj#: 71380.114 - ILD 980 683 197
Roll: 2 Photo #: 4
Date: 03/30/95 Time: 0913
Photographer: John Noyes
Description: Large lagoon with aerators, water, and rocky shore.
Onsite storage building in background. View is to
the northeast.

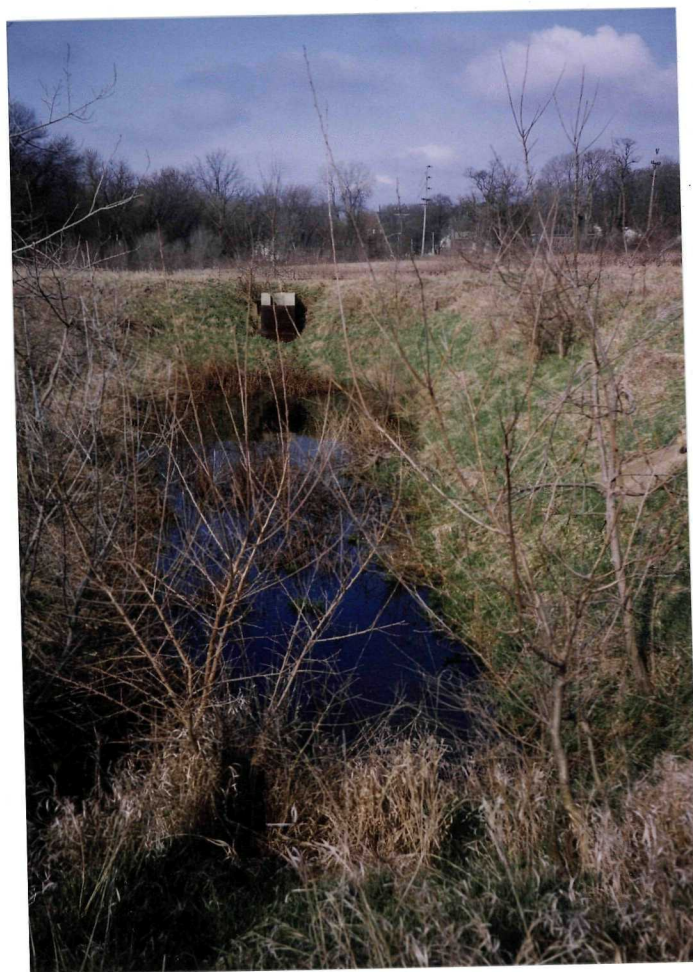
Site: Diamond International Corporation
Proj#: 71380.114 - ILD 980 683 197
Roll: 2 Photo #: 5
Date: 03/30/95 Time: 0915
Photographer: John Noyes
Description: The first small lagoon. Note the standing water
due to recent rains. Weir in background leads to a
sealed underground drainage pipe. View is to
the west.

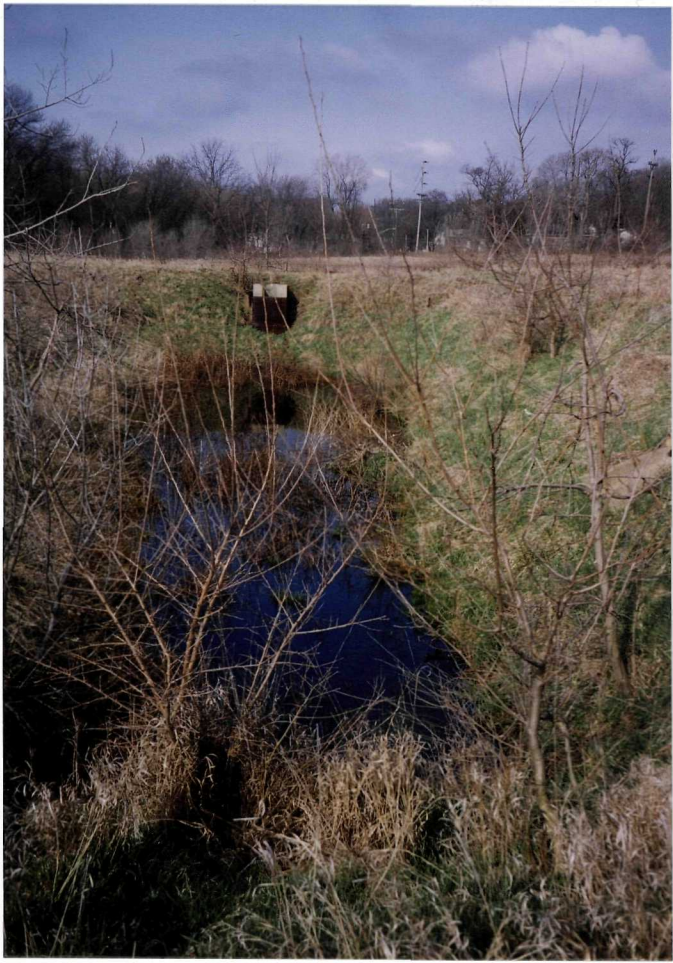
Site: Diamond International Corporation
Proj#: 71380.114 - ILD 980 683 197
Roll: 2 Photo #: 6
Date: 03/30/95 Time: 0915
Photographer: John Noyes
Description: The first small lagoon. Note the standing water due to recent rains. Weir in background leads to a sealed underground drainage pipe. View is to the west.

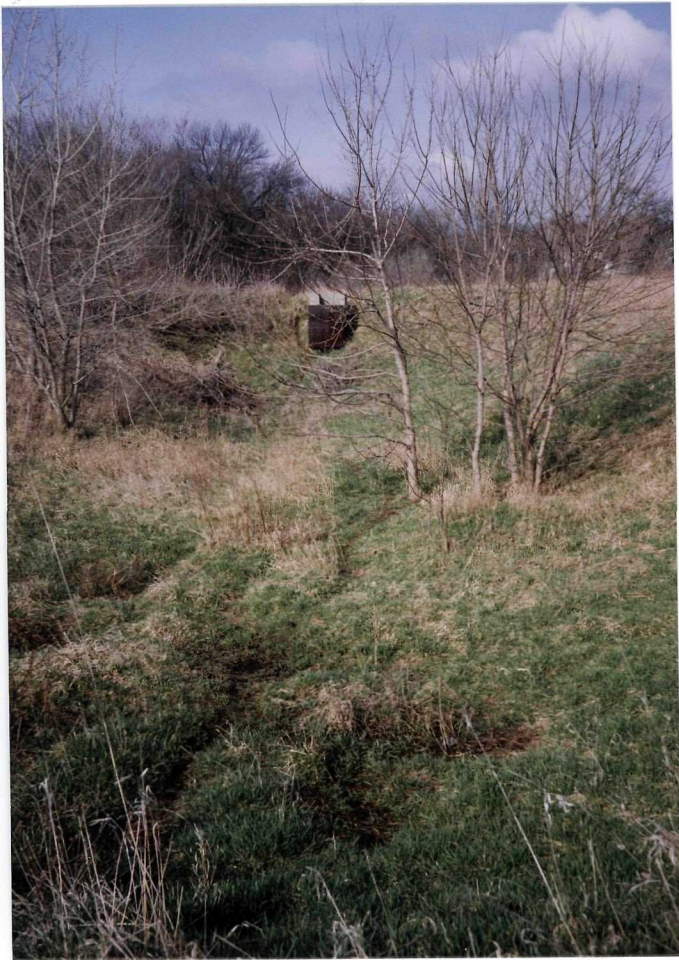
Site: Diamond International Corporation
Proj#: 71380.114 - ILD 980 683 197
Roll: 2 Photo #: 7
Date: 03/30/95 Time: 0918
Photographer: John Noyes
Description: The second small lagoon (south of the first small lagoon). No standing water. Weir in background leads to a sealed underground drainage pipe. View is to the west.

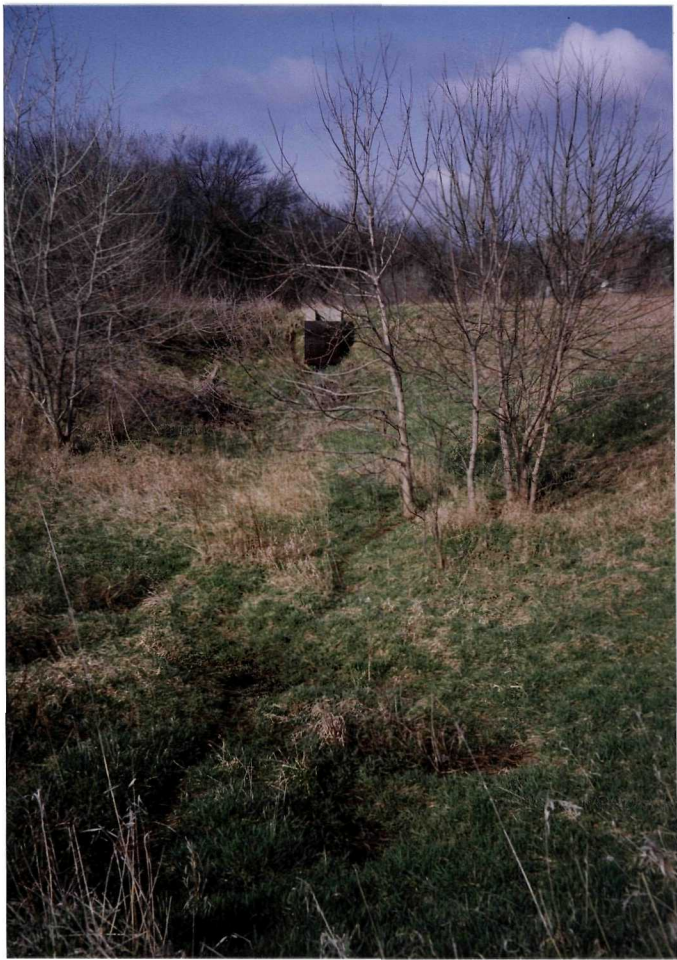
Site: Diamond International Corporation
Proj#: 71380.114 - ILD 980 683 197
Roll: 2 Photo #: 8
Date: 03/30/95 Time: 0918
Photographer: John Noyes
Description: The second small lagoon (south of the first small lagoon). No standing water. Weir in background leads to a sealed underground drainage pipe. View is to the west.

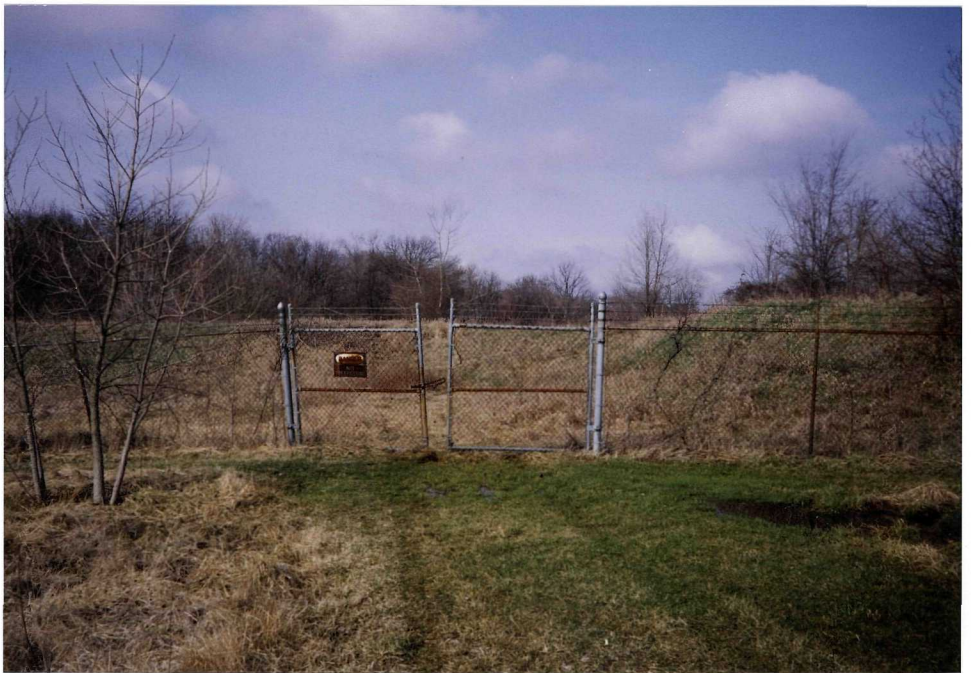
Site: Diamond International Corporation
Proj#: 71380.114 - ILD 980 683 197
Roll: 2 Photo #: 9
Date: 03/30/95 Time: 0925
Photographer: John Noyes
Description: Gate and fence enclosing surface lagoons. Note berms inside fence surrounding each lagoon. View is to the west.

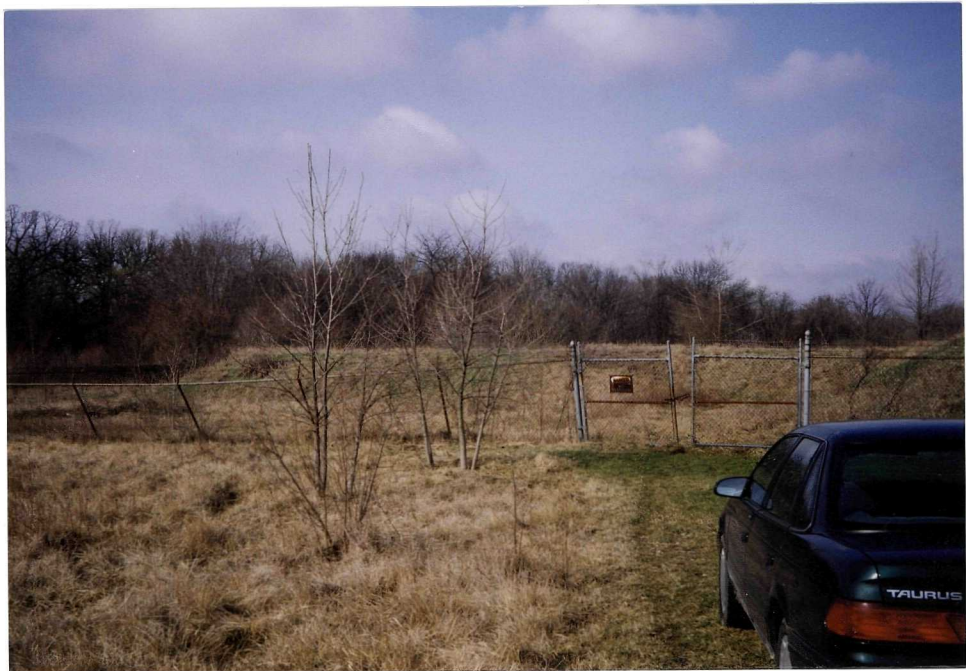
Site: Diamond International Corporation
Proj#: 71380.114 - ILD 980 683 197
Roll: 2 Photo #: 10
Date: 03/30/95 Time: 0925
Photographer: John Noyes
Description: Gate and fence enclosing surface lagoons. Note berms inside fence surrounding each lagoon. View is to the west.
